INVESTIGATION INTO THE WELDED FILLING QUALITY OF A LOCALLY RESTORED BALL JOINT

*J.M. Musharif and S.D. Rasika Perera**
Department of Mechanical Engineering,
The Open University of Sri Lanka, Sri Lanka

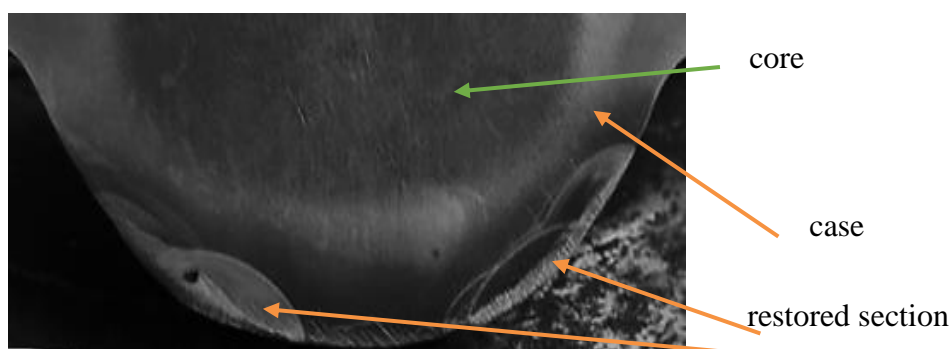
Figure 2 – Section of a locally restored ball of a type A damage stud, 2% Nital etch

The initial investigation of the section in Figure 2 shows three distinct regions, core in the middle and the case on the surface. In addition to the core and the case, there was another section which at a glance looked alien. This section can easily be identified as the restored section by local welding and subsequent machining. The depth of the case-hardened layer was about 5mm. An image of the fusion zone obtained under the microscope is given in Figure 3.

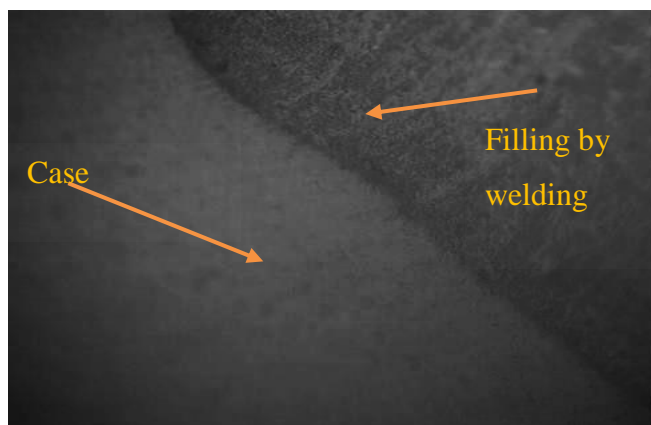
Figure 3 – Fusion zone of case and welded filling

The case was subjected to heat treatment and should be the hardest section. The core is the parent material and is not subjected to surface hardening. The hardness in the case was in the range of 38 to 40. The core had a hardness of 28.5 to 30. Ideally, the restored metal filling part also should fuse finely with the parent material and have a higher hardness. The analysis revealed that the restored part did not have the required hardness compared to the parent material. Further, Figure 3 which depicts the fusion zone shows that the welding zone was not fused properly to the parent material.

It is evident from the facts such as the poor fusion with the parent material, and the hardness reduction in the welded zone compared to the parent material that the restoration process is not satisfactory. A hardness reduction of 44% was observed in the welded section compared to that of the case-hardened section of the parent material. It can be recommended to carry out a suitable heat treatment procedure before welding to the parent material to accommodate better fusion and carryout a surface hardening for the restored ball and stud in order to accommodate a homogenous micro structure with high surface hardness.

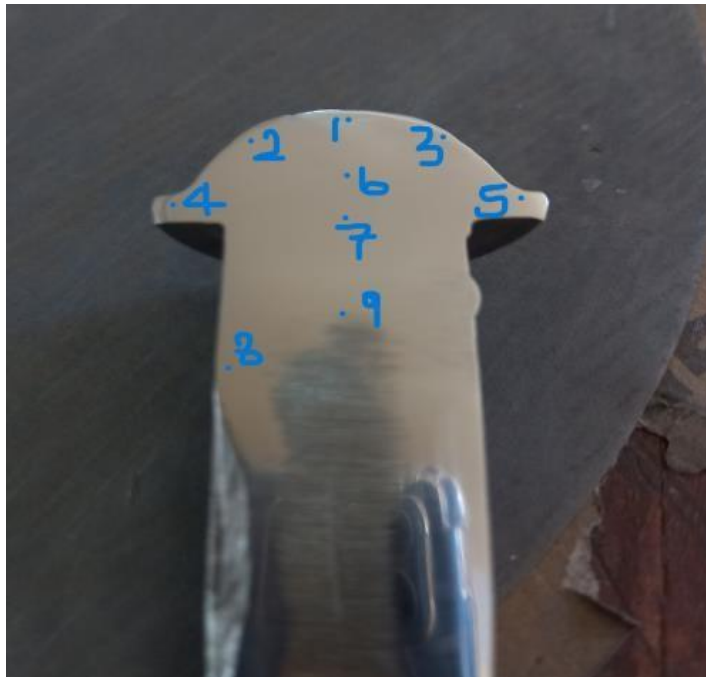
Figure 4 – Hardness measuring points of specimen

Referring to Figure 4, where the hardness was tested in various points on the stud section, the hardness at points 2 and 3 are located in the welded zone, whereas points 7, 8 and 9 are from the core. Points 1,4 and 5 are from the case. The hardness results are given in Table 1.

Points on specimen	Hardens Number HRC
1	38
2	22.5
3	21
4	38
5	40
6	30
7	30
8	29
9	28.5
