INVESTIGATION INTO THE WELDED FILLING QUALITY OF A LOCALLY RESTORED BALL JOINT

*J.M. Musharif and S.D. Rasika Perera**
Department of Mechanical Engineering,
The Open University of Sri Lanka, Sri Lanka

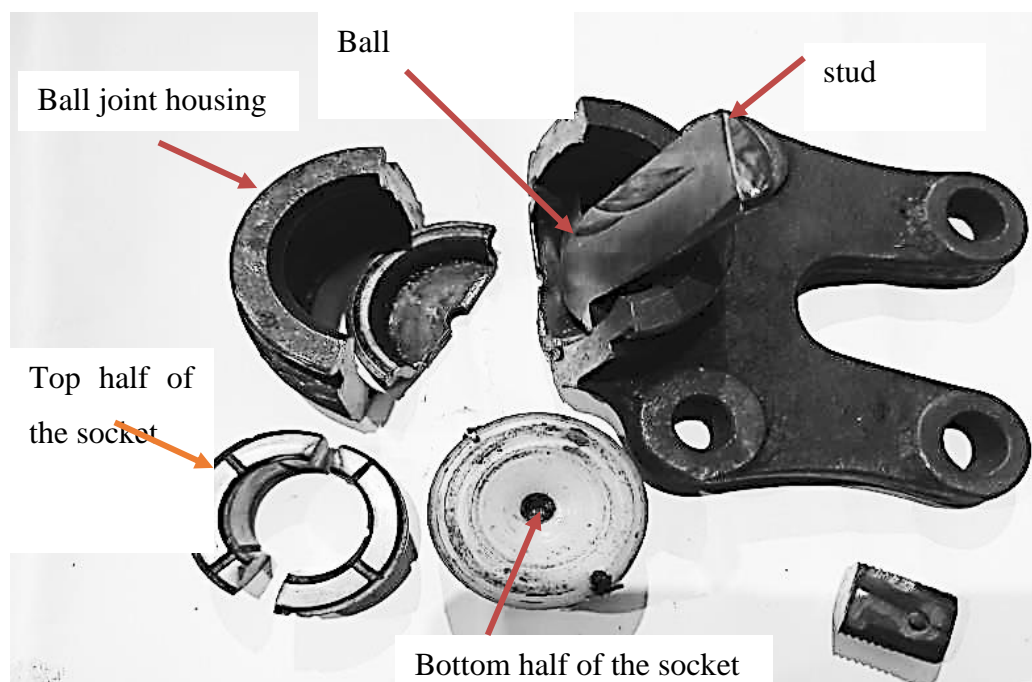
Figure 1- Vertical cut of a ball joint

A vertical cut of the investigated ball joint is shown in Figure 1. The ball and stud is fabricated as one unit from alloy steel and induction hardened. The top and bottom sockets are being made from polymer material such as nylon or teflon. Cold-hot forming is used by the mechanical part manufacturing industries for mass production of small or medium sized mechanical parts, (Davis & Semiatin, 1988). In forging, initial materials which are cut from bars, are formed progressively to final shapes by operations including shearing, upsetting, forward and backward extrusion, piercing, etc. (Im et al., 1999).
